## A study on corrosion of distance piece on Exhaust Gas Cleaning Systems (EGCS) discharge water line

**Abstract:** An exhaust gas cleaning system (EGCS) is a requisite in ships for complying with the IMO 2020 global sulfur limit requirements. However, corrosion in the distance piece between the EGCS overboard valve and ship hull can cause a large amount of seawater to enter the engine room. Although the distance piece is constructed according to an approved design employing steel piping with an epoxy coating, acidic wash water still comes into contact and reacts with the steel pipe. This is most likely caused by a defect in the epoxy coating or damage to the coating incurred during pipe installation. The results of this study show the importance of maintaining cleanliness during surface treatment and proper painting thickness during pipe installation. This study focuses on the importance of selecting the correct design and appropriate materials for the EGCS discharge water distance piece.

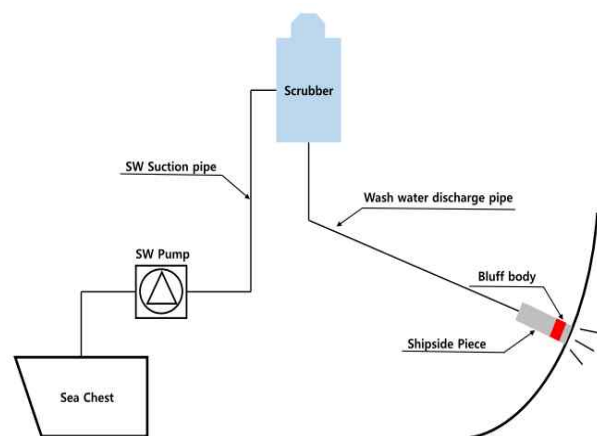
Recently, sea water leakage was detected from distance pieces comprising steel pipes with epoxy painting inside, connected to the hull on the EGCS SOx scrubber discharge water line, as shown in **Figure 1** [6].

**Figure 1:** EGCS SOx scrubber discharge water line

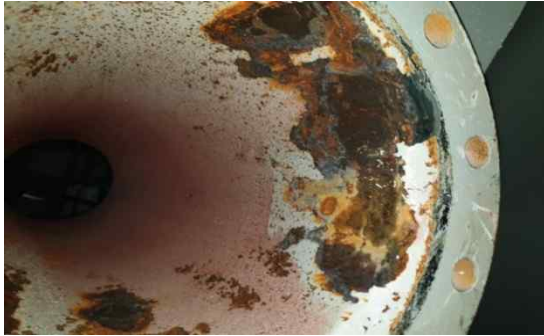
Leakages have been detected around welds between distance pieces and the flange, or bluff body welding area; the corrosion progressed around the welds, resulting in leakages. The bluff body, which is necessary to dilute the acidic outflux of the EGCS SOx scrubber wash water and ensure compliance with the emission regulations, was found to be heavily corroded, as shown in **Figure 2** [5].

**Figure 2:** Corrosion around welds in distance piece and bluff body corrosion.

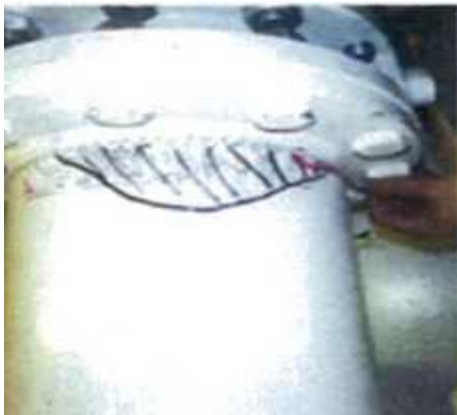
**Figure 3:** (a) Corrosion area on the distance piece, (b) pipe thickness between pipe and flange

Although the distance piece was made according to an approved design comprising steel piping with epoxy coating, the acidic wash water managed to come into contact with the steel pipe and react. Most likely this was due to a flaw in the application of the epoxy coating or damage to the coating incurred during the final installation, either of which is very difficult to find during installation [5].

Nevertheless, three months after installation of the EGCS SOx scrubber, sea water leakage occurred at the location between the pipe and the flange, as shown in **Figure 3 (a)**. **Figure 3 (b)** shows the thickness data, demonstrating that corrosion was already in progress over a large area.

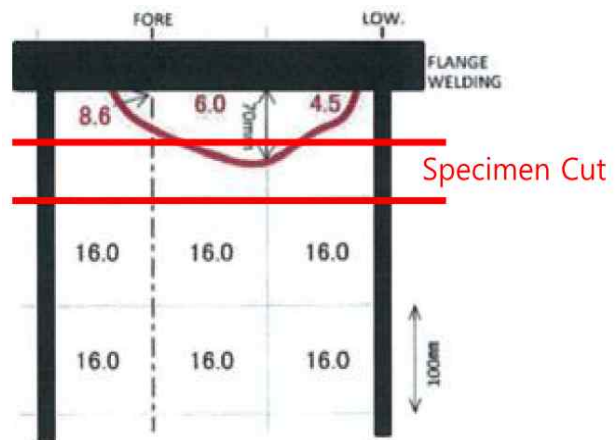
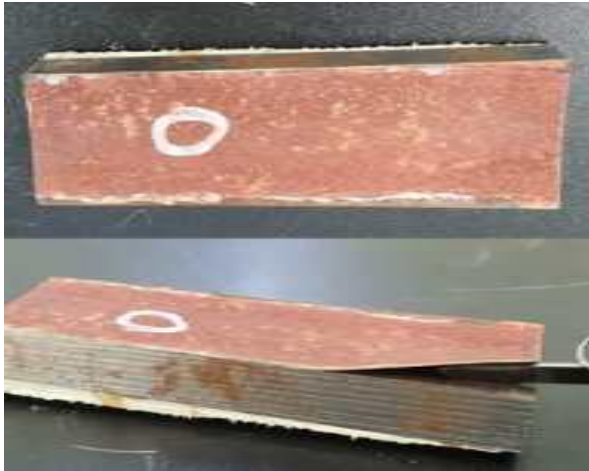
**Figure 4:** (a) Cutting area and (b) specimen of corroded pipe from ship

Internal inspection showed that the pipe was severely corroded, and most of the coatings on the edges between the pipe and flange were detached, as shown **Figure 4 (a) and (b)**. Microscopic analysis showed that the coating failure was caused by improper surface preparation, which included the surface profile and contamination underneath the coating film of the distance pieces. The measured surface profile underneath the coating was lower than the SA 2.5 surface preparation requirement, and contaminants were observed, leading to failure of the adhesion of the coating to the substrate (the surface profile for SA 2.5 surface preparation is 30–70 µm).

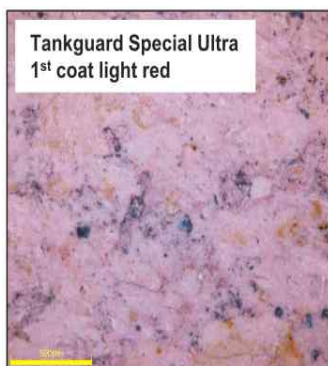
**Figure 6:** Contaminants of steel dust on the inner coating

Although the inside of the pipe was properly cleaned before painting, rust was observed on the detached coating under a microscope, as shown in **Figure 6**. Contaminants other than rust were observed underneath the film, indicating that steel dust was not properly removed from the substrate before application, lowering the adhesion to the pipe surface, as shown in **Figure 7**. Therefore, it is deduced that coating failure was caused by improper surface preparation, including the surface profile and contamination of the distance pieces.

The cause of corrosion in the distance piece pipe is improper surface preparation, including the surface profile and contamination underneath the film coating of the distance piece, as confirmed by microscope analysis. This result shows the importance of sufficient surface treatment and maintaining cleanliness during the installation of distance pieces, as well as having sufficient paint thickness.

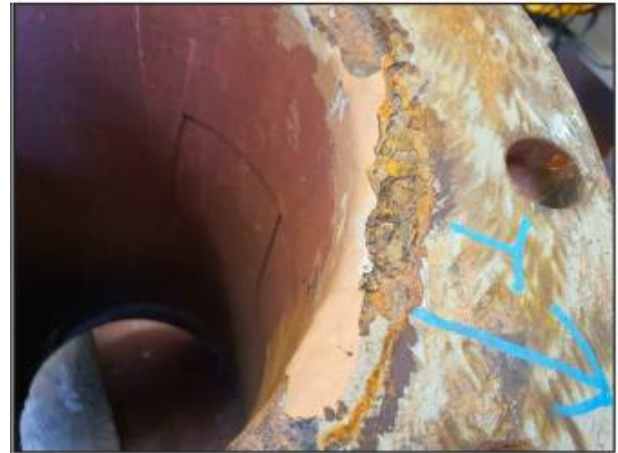
**Figure 7:** Feature of corroded pipe in the ship

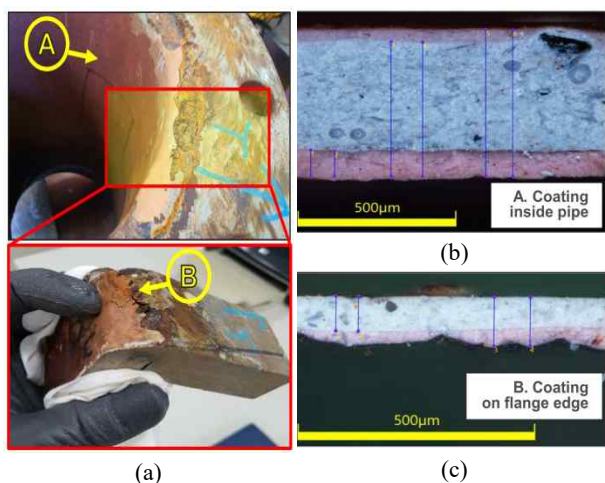
**Figure 8:** Microscope analysis of cross-section of coating film; (a) surface image of corroded area, (b) coating inside pipe, and (c) coating on flange edge

However, the coating thickness on the edges was significantly lower than the minimum required thickness of 300 μm or more, which indicates that the chemical resistance of the film on the

edges was not adequate, as shown in **Tables 1 and 2**, and **Figure 8**. Therefore, it is deduced that the acidic EGCS SOx scrubber wash-water penetrated through the coating from the edges and corroded the substrate.
