Empirical case study of black-out incident caused by incomplete combustion and blow-by in ship generator engines

Jong-hun Im¹ · Beom-seok Rho² · Sang-deuk Lee[†]

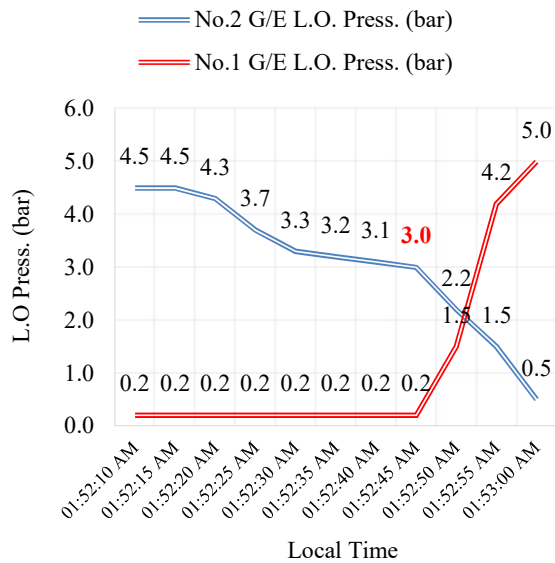
Figure 1: AMS Trend of Generator No. 1 & 2 Engine Lubricating oil (G/E LO) Pressure

The analysis of the AMS data, illustrated in **Figure 1: AMS Trend of No.1 & No.2 G/E LO Pressure**, provides critical insights into the events leading up to the blackout incident. This section discusses the specific factors that contributed to the pressure decline and subsequent generator shutdown.

Figure 1 displays the time-series data of the LO pressure for Generator No. 1 and 2. At the outset, the LO pressure for Generator No. 2 was maintained at 4.5 bar, which was slightly below the manufacturer's recommended pressure of 5.0 bar, and was considered stable by the crew based on historical operational data.

pressure under these intensified conditions, the LO pressure of Generator No. 2 began to decline. As shown in **Figure 1**, the pressure drop started at 4.5 bar and gradually decreased over the following 25 s. This decline accelerated as the generator continued to experience the compounded effects of the steering maneuver, air compressor load, and oil viscosity changes.

- **At 4.3 bar:** the pressure exhibited signs of instability. Although not yet critical, this decrease indicates that the system was in duress.
- **At 3.7 bar:** the pressure drop became more pronounced, indicating that the lubrication system failed to compensate for the operational stresses.
- **At 3.3 bar:** the generator approached the critical failure point. The ongoing inability of the LO system to stabilize the pressure led to increased mechanical friction and heat, further exacerbating the problem.
- **At 3.0 bar:** the pressure decreased to the shutdown threshold. Recognizing the imminent risk of severe mechanical damage, the generator safety systems automatically initiated a shutdown to protect the engine.

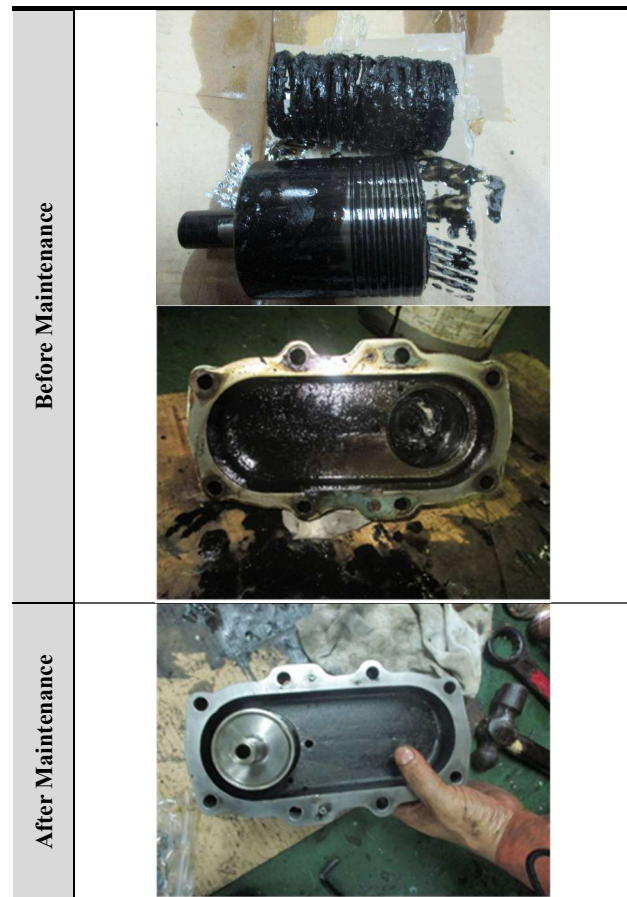
Figure 3: G/E LO Pump Relief Valve

The "LO Pump Relief Valve" is designed to maintain the discharge pressure from the LO pump at a constant level, typically set to 5 bar as per the manufacturer’s specifications. However, during inspection, it was discovered that this valve had

accumulated a significant amount of carbon sludge. **Figure 3** provides a visual evidence of the condition of the relief valve before and after maintenance.

In the "Before Maintenance" state, the valve showed heavy carbon deposits that had hardened over time, leading to the loss of elasticity in the internal spring. This buildup compromised the valve's ability to maintain the correct pressure, contributing directly to the pressure drop observed in Generator No. 2.

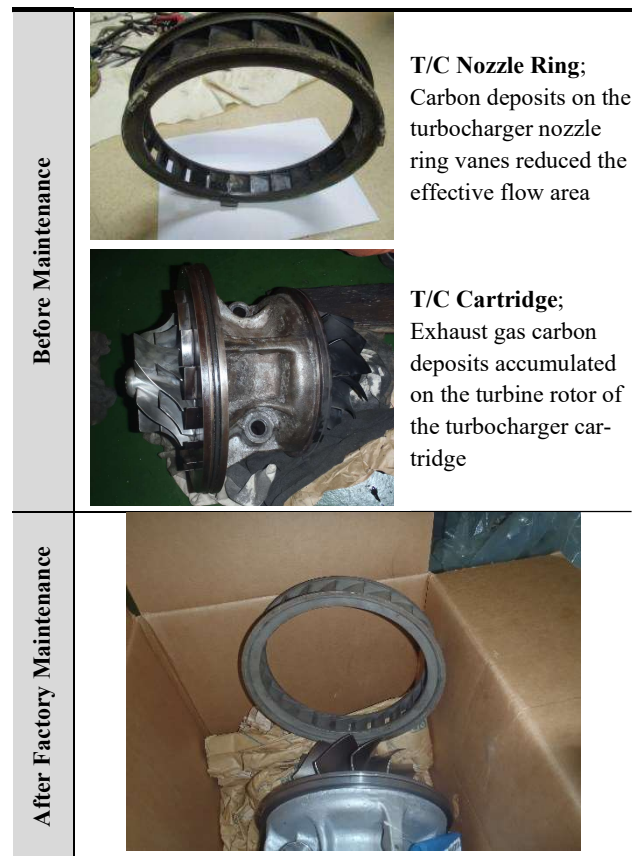
Figure 4: G/E Turbocharger

- **Abnormal Exhaust Gas Temperatures:** Under normal operating conditions, the exhaust gas temperature at the inlet of the turbocharger should be within the range of 450–550 °C. However, it was frequently observed that this temperature exceeded the acceptable limit, often rising above 580 °C. This abnormal increase in temperature was occasionally accompanied by a surging phenomenon, indicating instability in the combustion process.
- **Carbon Deposition on Turbocharger Components:** To address these issues, engineers routinely disassembled the turbocharger to clean significant carbon deposits found on the exhaust side of the turbine rotor and nozzle ring. After reassembling the cleaned components, the exhaust gas temperature temporarily returned to normal. However, this is a

short-lived solution, as an abnormal temperature increase would reoccur after approximately 1,000–1,500 h of operation.

- **Visual Evidence:** **Figure 4** illustrates the condition of the turbine rotor and nozzle ring before and after maintenance, highlighting the extent of carbon deposition due to incomplete combustion.

3. **Air Supply System Maintenance:** To ensure stable scavenging of air pressure according to the engine load, it is recommended that scavenging air filters be replaced weekly, air coolers undergo annual chemical cleaning, and turbochargers be cleaned with water during operation, according to the manufacturer’s guidelines.

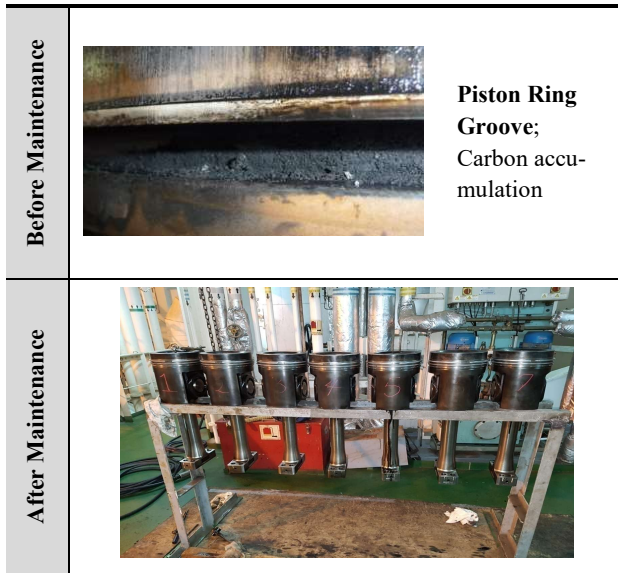
Figure 5: G/E Piston

- **Carbon Clogging in Piston Components:** During overhaul of Generator No. 2, it was discovered that the grooves of the piston and oil scraper rings were clogged with carbon deposits. These deposits blocked the drain holes, significantly impairing the functionality of these components.
- **Replacement of Components:** As a corrective measure, all affected piston rings and oil scraper rings were replaced. In addition, the upper section of the cylinder liner, particularly the explosion area, exhibited a high wear rate.
- **Improvement in Operational Performance:** Following the overhaul, a significant improvement in generator performance was observed. Daily sump oil consumption

decreased from approximately 60 L to a normal level of approximately 10 L.

- **Visual Evidence:** **Figure 5** shows the condition of the piston ring grooves before and after the overhaul, emphasizing the effect of carbon buildup on engine performance.

2. **Piston Overhaul Interval:** The recommended overhaul interval of 16,000 h should be initially reduced to 8,000 h based on the observed wear. Further extensions may be considered based on engine performance and condition assessments during shortened intervals.

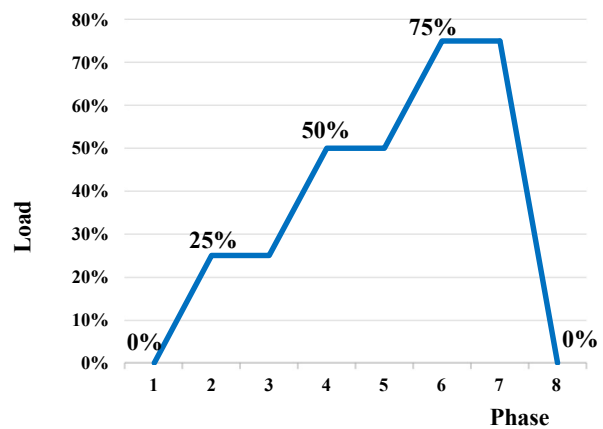
Figure 6: No. 2 G/E Load Test

Figure 6 shows the experimental setup and load conditions used during the tests. The generator load was increased incrementally, as detailed in **Table 4** (No. 2 G/E load test phase).

The results of the experiments confirmed the findings of the initial inspection. At all load levels, the LO pressure stabilized at 5.0 bar, indicating that the cleaning and maintenance procedures restored the system to its proper operating conditions. However, the cylinder explosion pressure was consistently lower than the manufacturer's design specification by approximately 3–5%, suggesting that incomplete combustion still occurred to some extent.

The sump tank pressure remains positive throughout the tests, further indicating the presence of blow-by gases in the crankcase. This finding is consistent with earlier observations of worn piston and scraper rings, which allowed combustion gases to escape into the LO system.
