Coating method for overboard pipes in exhaust gas cleaning system (EGCS) discharge water line

Abstract: An exhaust gas cleaning system (EGCS) is a relevant compliance to meet the IMO 2020 global sulfur limit requirements. However, due to the corrosion on the overboard pipe of the EGCS discharge water line, a large amount of seawater enters the engine room, which has a significant impact on the ship's operation. This is most likely caused by a defect in the coating or damage to the coating incurred during pipe installation. However, checking the ship where the pipe was corroded shows another cause of corrosion, and a very easy method could be developed to prevent recurrence of the same problem. This study focuses on the importance of the coating method for EGCS discharge water overboard pipes.

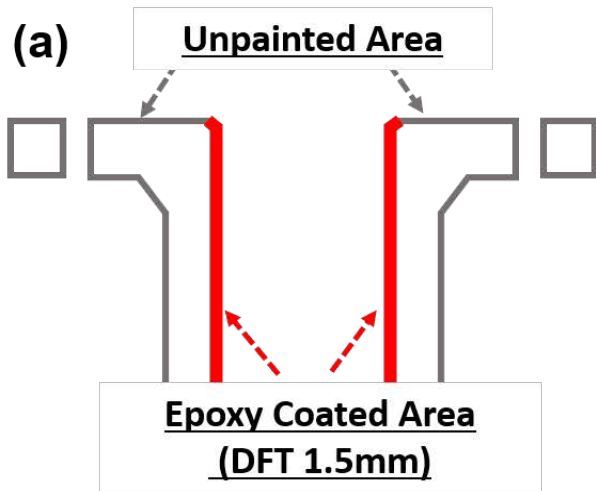
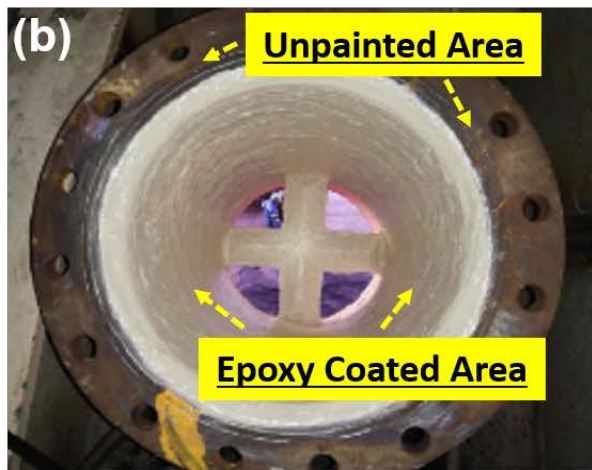
Figure 1: (a) Schematic of overboard pipe, (b) top view of flange surface with the unpainted area, and (c) corroded pipe

The general coating area and the general appearance are schematically displayed in **Figures 1(a)** and **(b)**, respectively. The inside coating was only painted up to the weld area and not on the

flange surface. This coating procedure was applied because there is no standard procedure for flange surface coating, and when the flanges are painted, the risk of seawater leakage through the gasket between the flanges increases.

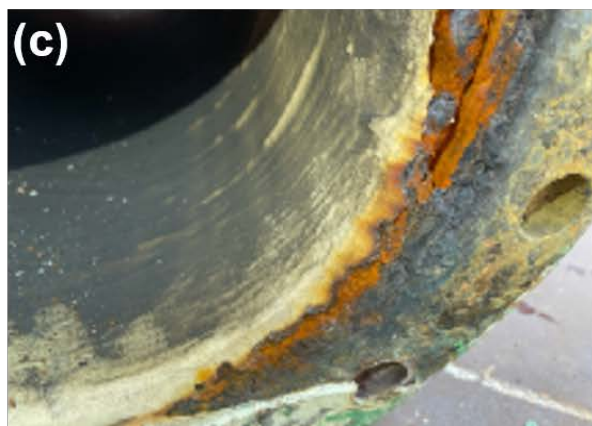
For ships with a corroded or destroyed distance piece, the flange surface was not painted uniformly, and it was confirmed by visual inspection that corrosion progresses at the boundary between the flange and the end of the inner tube coating and flange. In addition, a common characteristic of ships with corrosion failure at the distance piece was that there was no painting on the entire surface. This is because there was no standard procedure for flange surface coating when installing pipes at the repair shipyard, and the coatings were arbitrarily removed from the flange surface to avoid leakage through the gasket. Therefore, it was confirmed that the flange surface was not protected by the coating coming into contact with seawater, and corrosion first started at the painted end and the uncoated flange surface, as shown in **Figure 1(c)**.

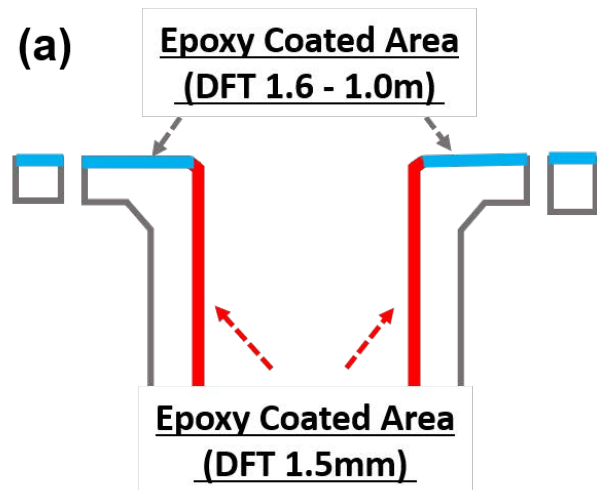
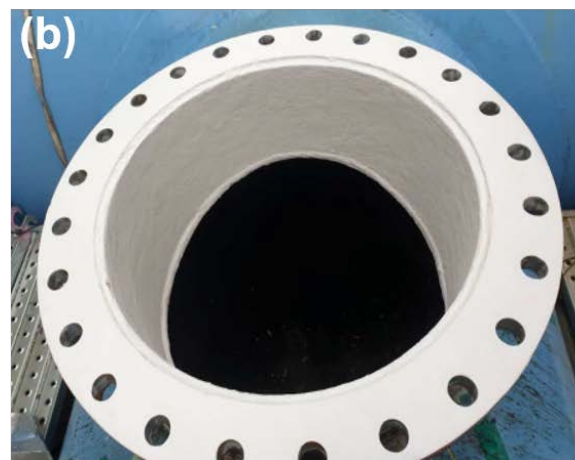
Figure 2: (a) Improved coating procedure for overboard pipe flange and (b) improved full coating on overboard pipe flange surface

This is an improvement to the pipe corrosion problem. The pipe flange surface was fully painted by an improved coating procedure to prevent pipe corrosion, as shown in **Figures 2(a)** and **(b)**. In addition, an appropriate coating procedure was developed and shared with repair shipyards to prevent the recurrence of the problem of uncoating on the flange surface. There was no pipe corrosion problem for two years after implementing the improvement plan.

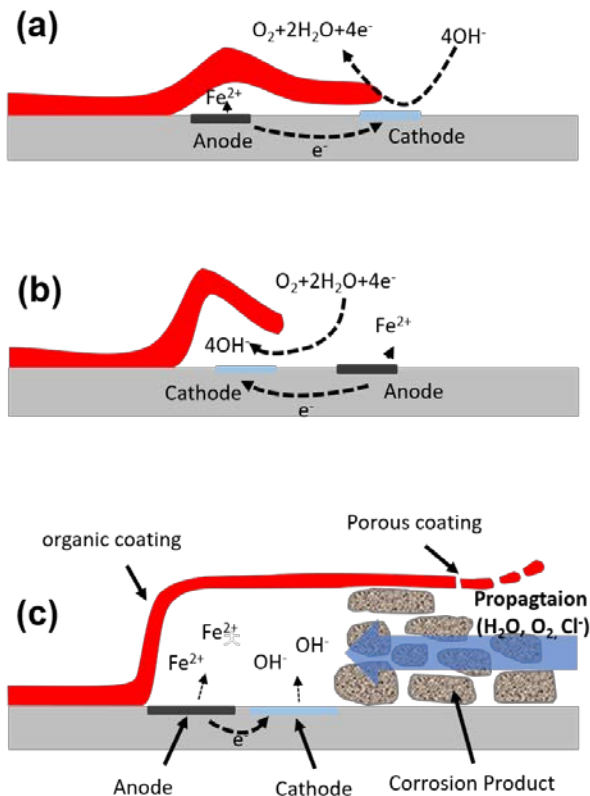
Figure 3: Corrosion at a coating end on a coated pipe. (a) Initiation of corrosion at the tail of painting, (b) corrosion progression in the delamination area, and (c) acceleration of corrosion with corrosion products.

Figure 3 shows the corrosion process on the flanges. Corrosion is initiated at the end of the organic coating on the flanges and is accelerated by sulfuric acid and chlorides, as shown in **Figures 3(a)** and **(b)**, as well as carbon dioxide, which enhances acidification at the corrosion site [8]. The corrosive cell structure under organic coating, shown in **Figure 3(c)**, consists of an active anodic site and an inactive tail saturated with corrosion products. The oxygen and chloride ions diffuse into the exfoliated spaces under the organic coating. Thus, a corrosion cell is established between an acidified anode at the head of the peeling progress

and an alkaline cathode at the tail of the peeling process, saturated with water and oxygen, whereas oxygen is reduced at the head of the filling.
