Corrosion behaviors of cement mortar specimens with different cover thickness in natural sea water

Abstract: This paper presents electrochemical corrosion behaviors of cement mortar specimens in the high salinity condition. Chloride ion is known as the most detrimental parameter to cause the corrosion in reinforced concrete. Increasing the concrete cover thickness is one of the corrosion protection methods against chloride ion; so, this study mainly focuses on the effects of mortar cover thickness on corrosion protection. In specimens, rebar, which was a height of 200 mm and a diameter of 10 mm, was installed at the center of the small size form. Later on, mortar was injected into the form, and 10, 20, 30, 40, and 50 mm of the different mortar cover thicknesses were selected. Potential measurements, linear polarization resistance tests, and cyclic potentiodynamic polarization tests were performed for specimens that were exposed to seawater. These results were compared with visual inspection results of rebar. The results show that an increase in the cover thickness contributes to corrosion protection. In addition, the result of electrochemical corrosion tests generally agreed with

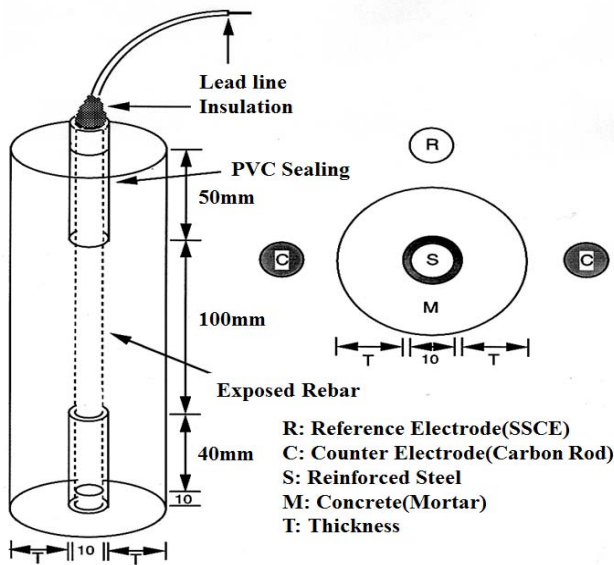
Figure 1 shows a schematic drawing of a cement mortar specimen. Ordinary round rebar (D10), which functioned as a working electrode, was positioned at the center of a small con-

crete specimen with a height of 200 mm and diameter of 10 mm. With the exception of the central area of the rebar (length of 100 mm), the specimen was sealed with polyethylene and silicon resin, which minimized the corrosion of the rebar due to the invasion of chloride ions from the top or bottom of the specimen. This meant that only chloride ions that entered from the side of the specimen could influence the corrosion behavior.

Figure 1: Schematic drawing of specimens

Following the positioning of the rebar, mortar was injected into the mold. Type 1 Portland cement (KSL 5201) was used. The cement mortar mixture had a fine aggregate: cement: water ratio of 2:1:0.45. Various cover thicknesses of 10, 20, 30, 40, and 50 mm were selected. Subsequently, curing was conducted by periodically pouring water over the specimen at the laboratory temperature of 25 °C. Following curing, a hole with a diameter of 1 mm and depth of 7 mm was drilled at the upper end of the rebar, and a copper cable was connected at this location for electrochemical testing. Moreover, the top and bottom of the specimen were sealed with epoxy to prevent chloride ion invasion via these sites.

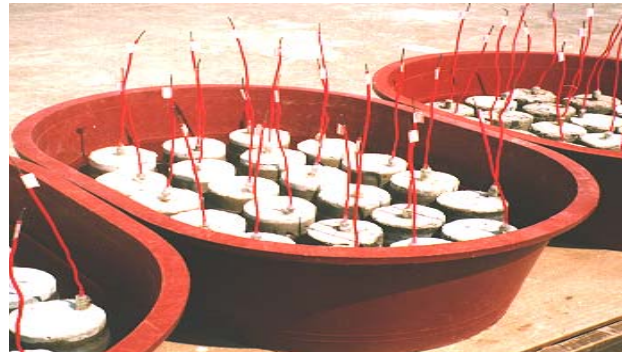
As shown in **Figure 2**, all the specimens were exposed to natural seawater at a depth of 15 mm. Subsequently, the tests commenced. The seawater was replaced periodically to ensure that the experimental conditions were similar to actual seawater conditions.

Figure 2: Specimens in sea water bath

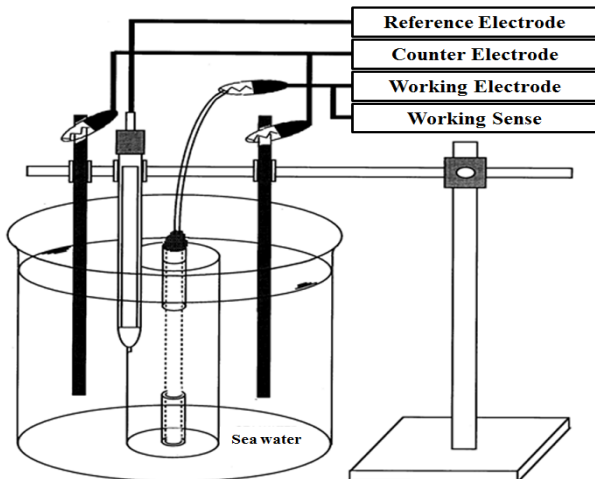
In addition, potentiodynamic polarization tests were performed to evaluate the relationship between the corrosion potential and current density, as well as the corrosion rate. These tests are also useful to qualitatively evaluate the passivation of a metal in a specific environment [13]. **Figure 3** depicts a schematic drawing of the potentiodynamic polarization test. In this test cell, two counter electrodes, fabricated using carbon, were positioned at both sides of the specimen. A uniform current distribution could be obtained from the arrangement of the two counter electrodes. A commercial potentiostat, Reference 600 (Gamry Instruments), was used to conduct the potentiodynamic polarization tests, and an SSCE was utilized as the reference electrode.

Figure 3: Schematic drawing of polarization test cell

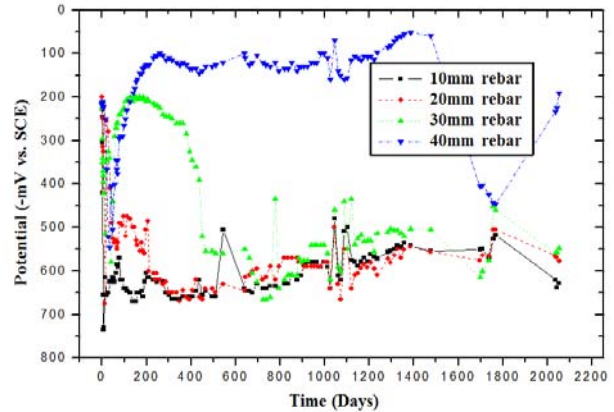
Figure 4 presents the variation in the potential of the specimens over a period of 6 years; an average value per month is presented to eliminate error factors. The results clearly show that the potential of each rebar differs depending on the cover thickness. Specifically, the specimen with the cover thickness of 40 mm has a greater potential, of approximately -100 mV/SCE, compared with the other specimens. The potential for the specimens with a cover thickness of 30 mm remains at -200 mV/SCE for a period of 400 days. However, the potential of the specimens with a cover thickness of 30 mm decreases to approximately -600 mV/SCE, and fluctuates frequently. In the case of the specimens with cover thicknesses of 10 and 20 mm, the corrosion potentials decrease over 100 days.

Figure 4: Potential variation of specimens

1. Potential measurements can be satisfactorily used to evaluate the degree of corrosion of reinforce concrete. In the case of the specimens with a cover thickness of less than 40 mm, the reinforcement exhibits severe corrosion.

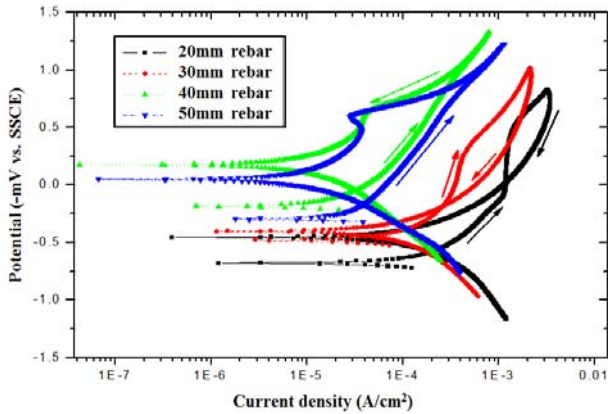
Figure 5 represents the results of the cyclic potentiodynamic polarization tests for the specimens with the various cover thicknesses of 20, 30, 40, and 50 mm. The corrosion current density of the specimen with the cover thickness of 40 mm is very low, less than 6×10^{-7} A/cm². In addition, the specimen with the cover thickness of 40 mm shows passivity behavior since it not only demonstrates a positive hysteresis pattern, which shows a lower current density in the reverse scan compared with those of the forward scan during the potentiodynamic polarization tests, but also high repassivation potential values. From the results, it is evident that a strong passive

film has formed on the rebar surface.

However, corrosion occurs in the case of the specimens with cover thicknesses of less than 40 mm. This is indicated by negative hysteresis behavior; higher current densities are obtained in the reverse scan compared with those of the forward scan during the potentiodynamic polarization tests. The corrosion current density of the specimen with the cover thickness of 20 mm is 5×10^{-4} A/cm², which is the highest amongst all the specimens.

Figure 5: Polarization diagram of specimens

In addition, in the case of the specimen with a cover thickness of 20 mm, pitting corrosion occurred (negative hysteresis behavior). A lower pitting potential, as well as the highest pitting current density, was obtained for this specimen. It is assumed that the passive film on the rebar surface was primarily destroyed by the extremely high current density due to the pene-

2. From the potentiodynamic polarization tests, it can be determined that the specimens with cover thicknesses of less than 40 mm exhibit pitting corrosion. The rebar surfaces do not maintain a stable state, and the passive film of the rebar surface is destroyed by chloride ions. However, the passive film is maintained for the specimens with a cover thickness of 40 mm.

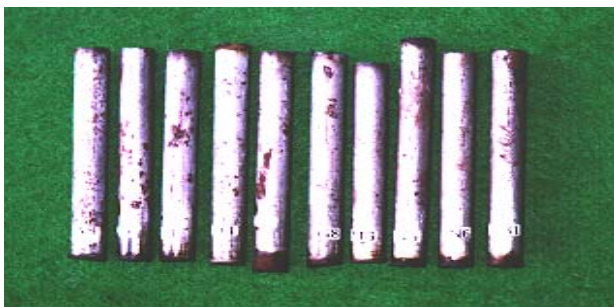
(a) rebar surface of 40 mm cover thickness

Figure 6: Autopsy visual inspection results

To measure the quantitative effects of the various cover thicknesses, the rebar was removed from the specimen, and a visual inspection was performed. As shown in Fig. 6, the rebar specimens were classified according to the cover thickness. In general, all the specimens with a cover thickness of 40 mm show less traces of corrosion compared with those with a cover thickness of 20 mm. In the case of the specimens with a cover thickness of 40 mm, less than 10% of the surface area is corroded while in the case of the specimens with a cover thickness of 20 mm, more than 70% of the surface area shows traces of corrosion.

From the results, it is evident that the cover thickness is a major factor for the maintenance or restoration of the passive film on the concrete reinforcement, which functions as a protective layer against chloride ion invasion. Finally, it can be determined from the visual inspection that the trend associated with the corrosion generally correlates with the results obtained from the electrochemical tests.

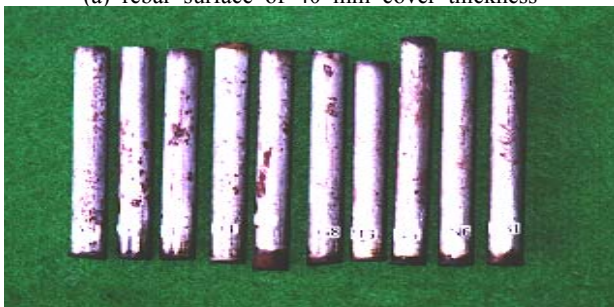
(b) rebar surface of 20 mm cover thickness
