Empirical case study of black-out incident caused by incomplete combustion and blow-by in ship generator engines

Jong-hun Im¹ · Beom-seok Rho² · Sang-deuk Lee[†]

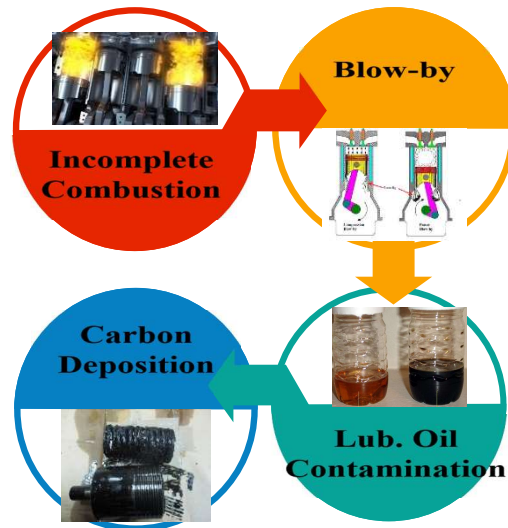
Figure 6: Illustration of the mechanical failure due to incomplete combustion

Figure 6 illustrates the process by which incomplete combustion leads to carbon build-up within the engine. This carbon deposition accelerates the wear of critical components, such as piston rings and cylinder liners, leading to blow-by and subsequent contamination of LO.

The lower-than-expected cylinder explosion pressure indicated that the engine did not operate at peak efficiency, likely owing to a suboptimal fuel-air mixture or other factors affecting the combustion process. This reduced efficiency not only increases the risk of mechanical failure but also contributes to higher fuel consumption and emissions, further underscoring the importance of addressing incomplete combustion in marine diesel engines.
